FAIRHAVEN DRAINAGE STUDY

Engineering Design Group, LLC

Project No. COVH0012

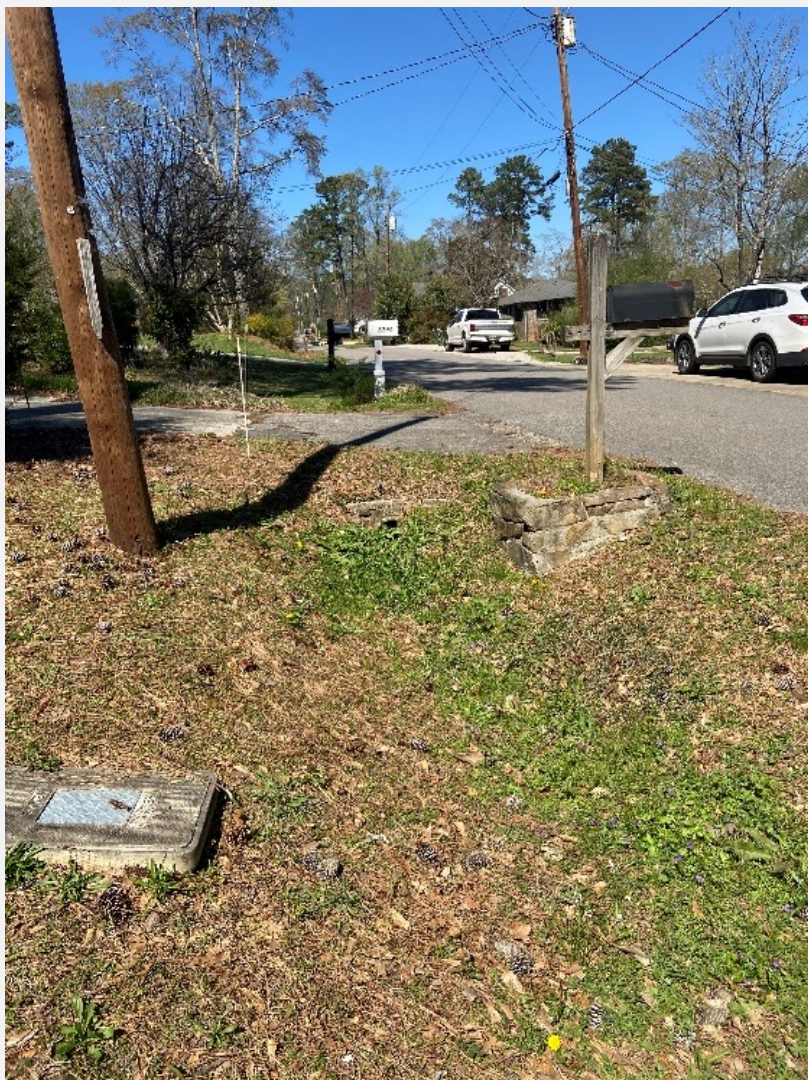
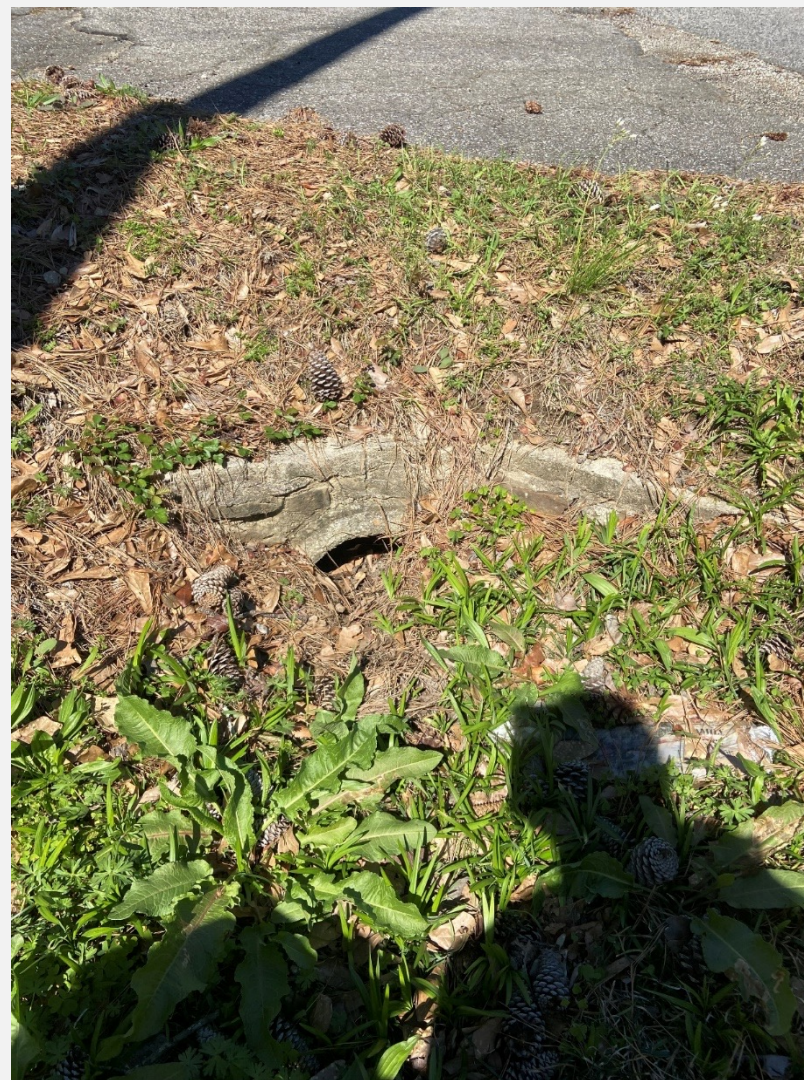
DRAINAGE AREA 1: PIPE B-2

- Existing grass swales/ditches and appropriately sized pipes within ROW
- Pipe B-2 along the west side of Glass Drive
- Pipe D-1 that travels west to east underneath Glass Drive
- Detention pond located at 3130 Overton Road in Mountain Brook

- Short Range: (City of Vestavia)
 - Inspect and clean pipes along Glass Drive
 - Clean and regrade Grass swales/ditches within ROW
- Long Range: (City of Mountain Brook)
 - Pipe D-1 should be replaced with a 24" pipe.
 - Pipe B-2 should be replaced with an 18" pipe.
 - Additional design effort should be performed on the existing detention pond.

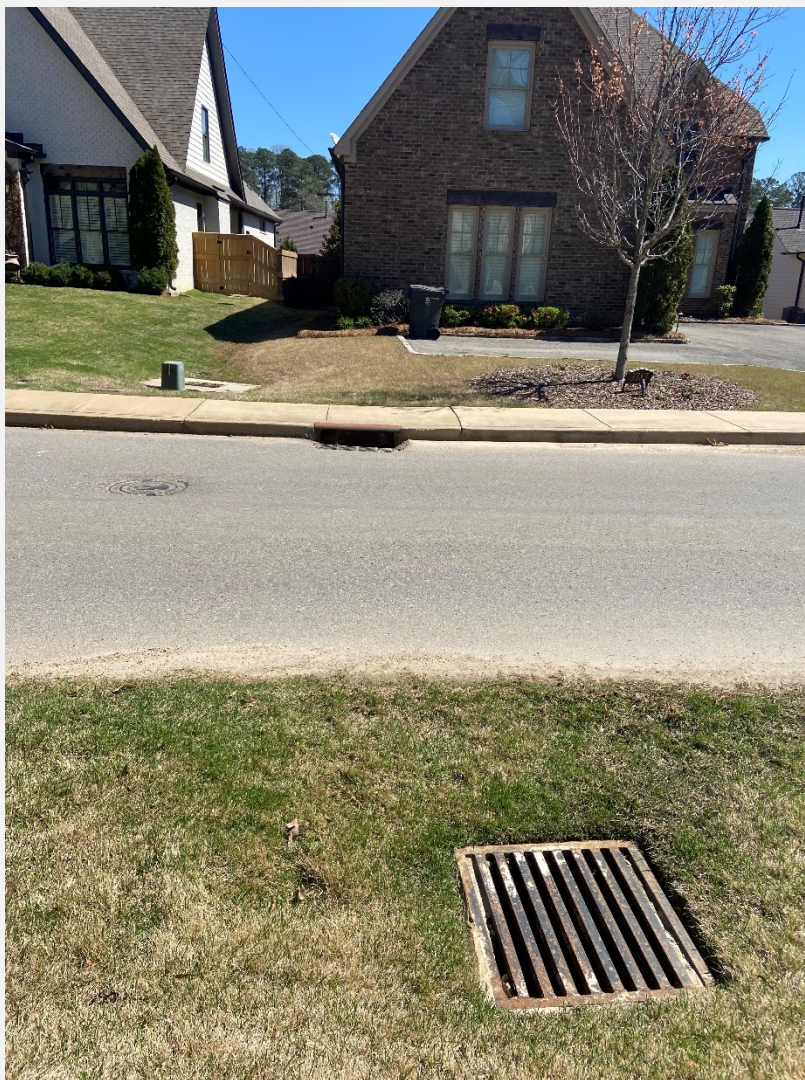
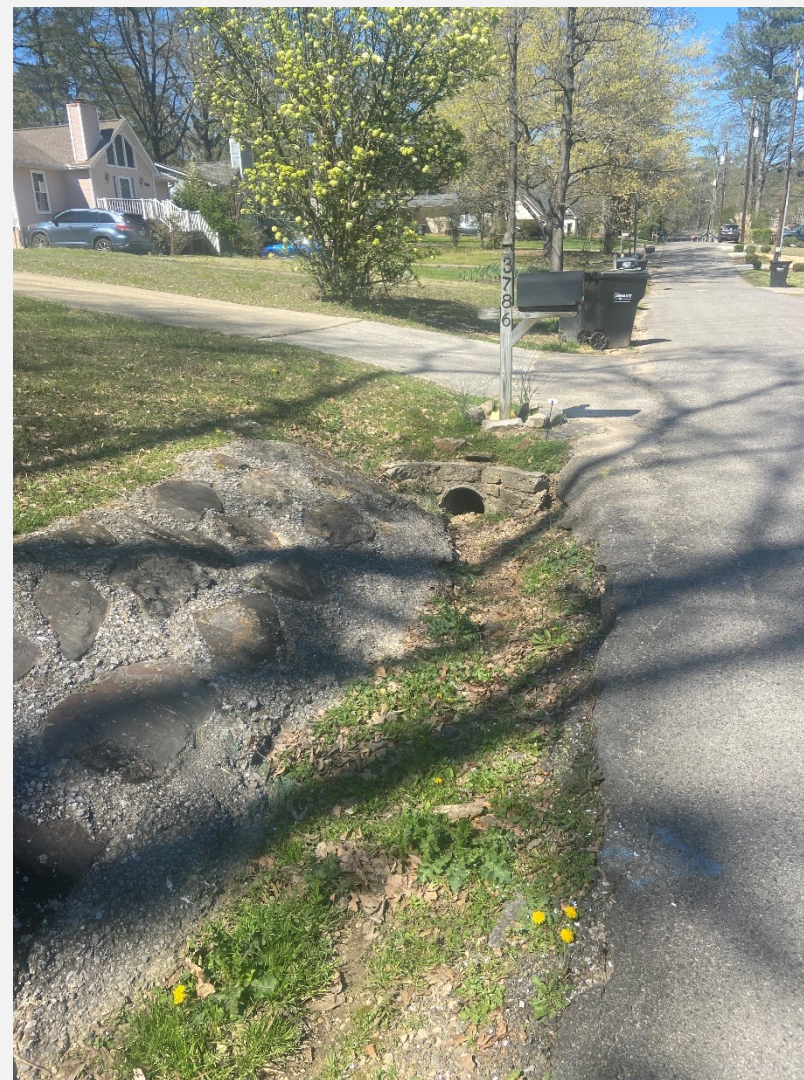
DRAINAGE AREA 2: PIPE C-7 AND B-1

- Existing pipes within ROW not being appropriately sized
- Unknown pipe sizing of infrastructure running from 3785 Glass Drive to 3786 Poe Drive
- Unknown outlet pipe of inlet 7C
- Pipe F-1 not appropriately sized
- Unknown outfall location of pipe E-5 that runs between 3785 Poe Drive and 3787 Poe Drive

- Short Range:
 - Inspect and clean pipes along Glass Drive
- Long Range:
 - Survey pipe infrastructure and replace all storm pipe that does not meet the required design size.
 - Verify that inlet 7C does not have an outlet pipe. Install 24" pipe from inlet 7C to junction structure at 3787 Poe Drive.
 - Determine outfall location of 36" pipe (E-5) that runs between 3785 Poe Drive and 3787 Poe Drive through survey or video efforts.

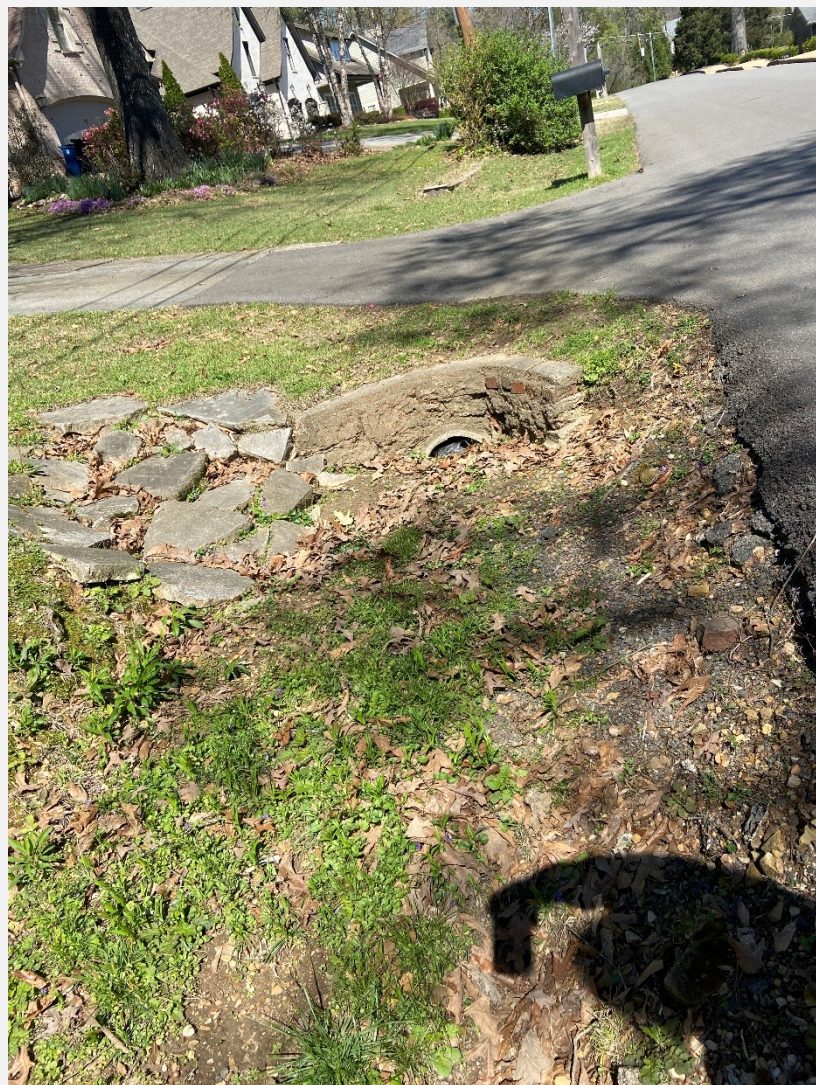
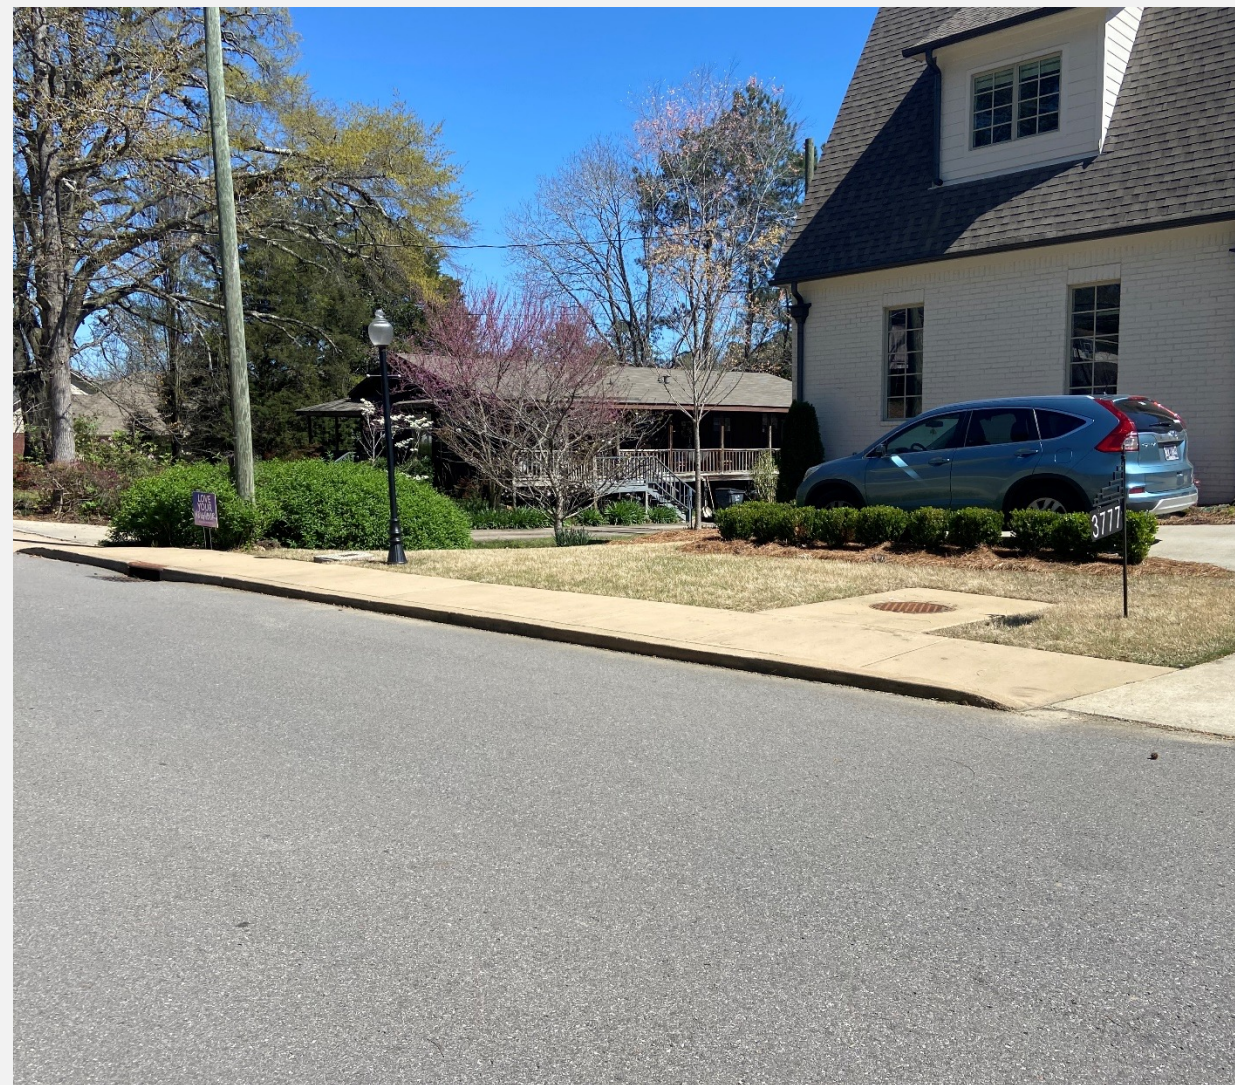
DRAINAGE AREA 3A: POE DRIVE

- Existing grass swales/ditches and appropriately sized pipes within ROW
- Pipe D-1 that travels west to east underneath Glass Drive
- Pipe H-1 underneath the driveway of 3776 Poe Drive
- Pipes I-1 and I-2 underneath Poe Drive and into 3777 Poe Drive

- Short Range:
 - Inspect and clean pipes along Glass and Poe Drive
 - Determine size and outfall of pipe D-1
- Long Range:
 - Pipe H-1 should be replaced with an 18" pipe.
 - Pipes I-1 and I-2 should be replaced to 24" pipes.

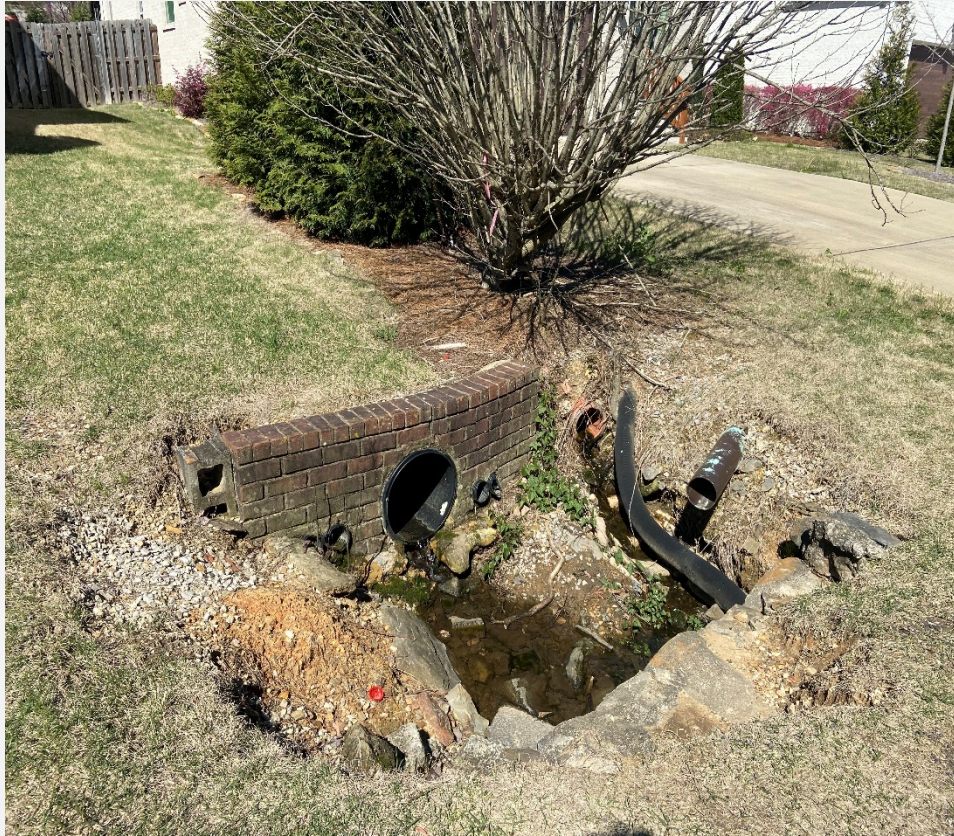
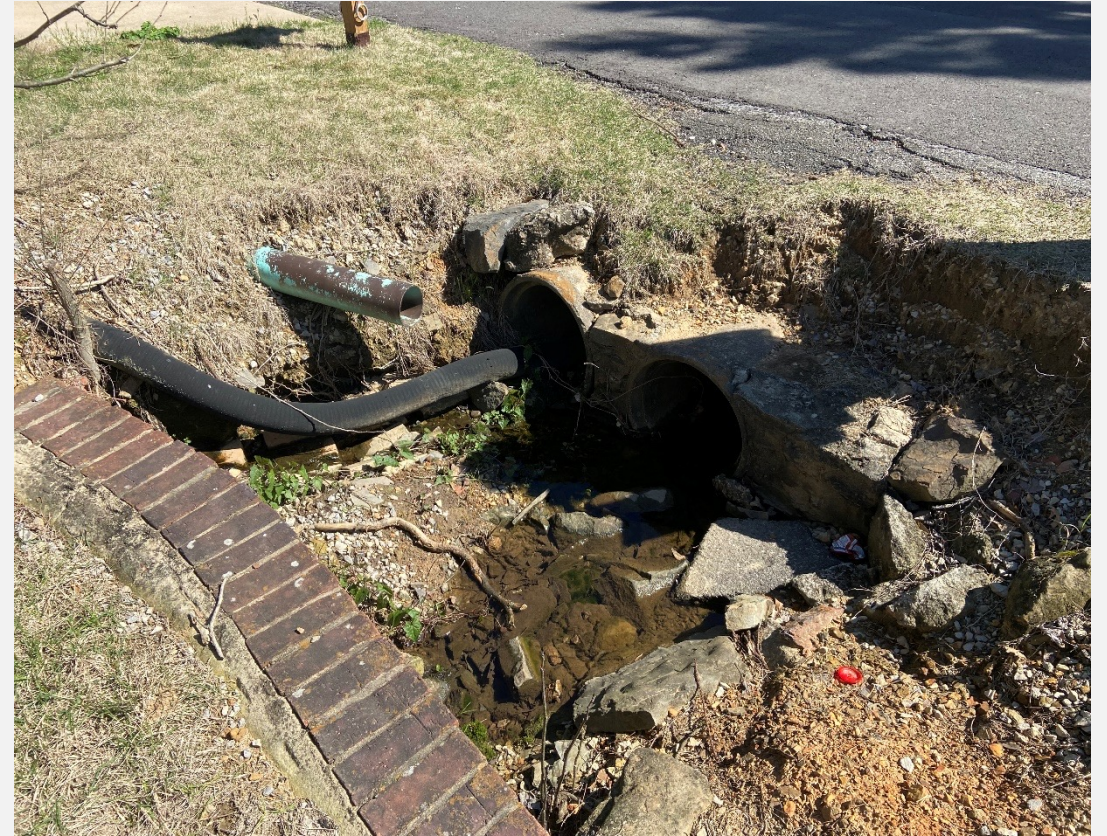
DRAINAGE AREA 3B: FAIRHAVEN

- Two pipes discharging from the junction at 3776 Fairhaven Drive and 3778 Fairhaven Drive
- The junction at 3776 Fairhaven Drive and 3778 Fairhaven Drive
- Pipe K-1 that begins in the rear yard of 3776 Fairhaven Drive

- Short Range:
 - The two 18” pipes discharging from the junction at 3776 Fairhaven Drive and 3778 Fairhaven Drive should be cleaned and investigated. After additional investigation, a more clear design decision can be made to mitigate the drainage issues around these two outlet pipes.
 - The junction at 3776 Fairhaven Drive and 3778 Fairhaven Drive is eroding and should be replaced with a structure.
- Long Range:
 - The existing 18” pipe (K-1) that begins in the rear yard of 3776 Fairhaven Drive but should be replaced with a 24” pipe.
