FAIRHAVEN DRAINAGE STUDY

Engineering Design Group, LLC

Project No. COVH0012

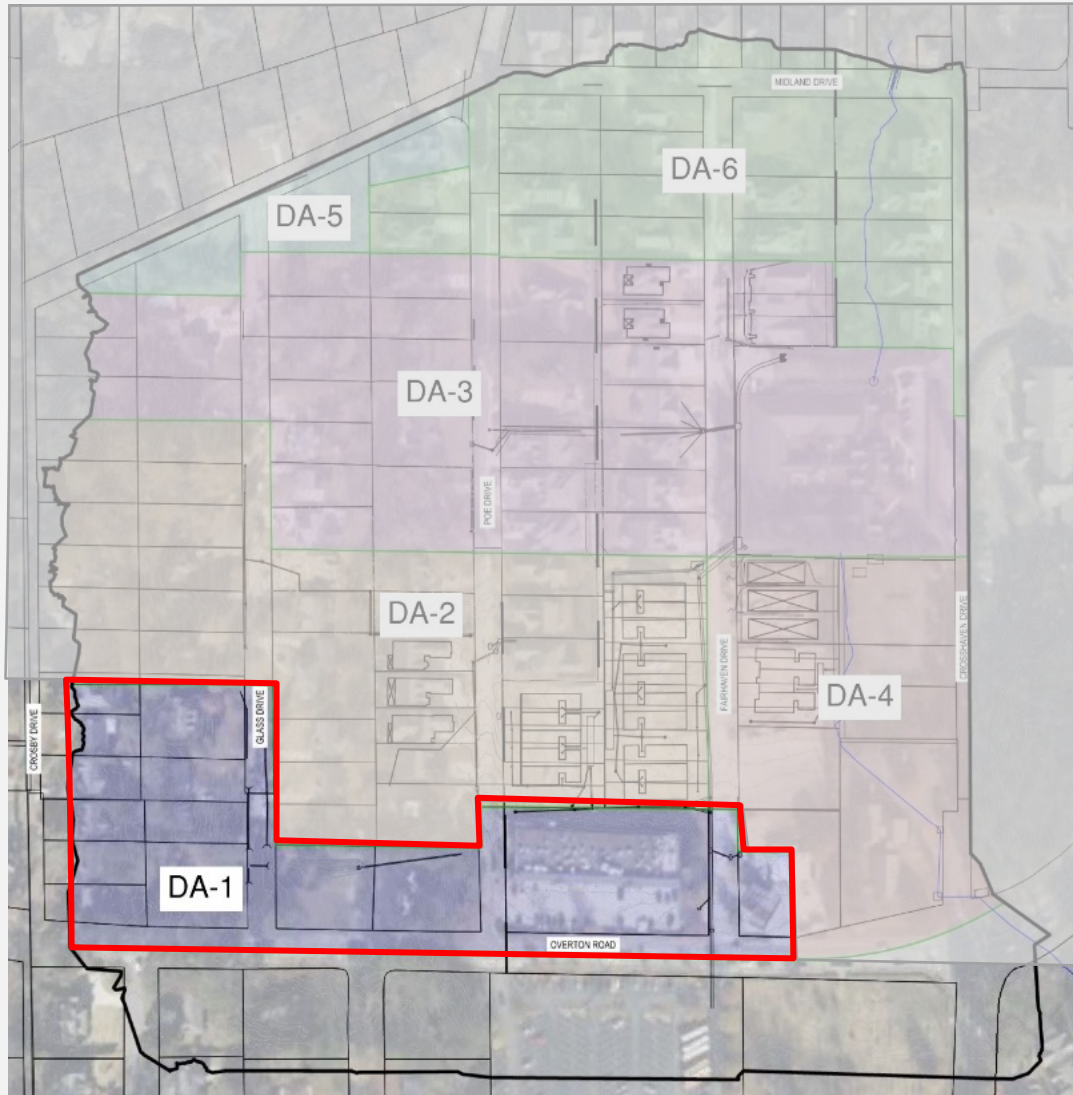
DRAINAGE AREA 1

Summary of Concerns:

- Overgrown grass swales and ditches
- Clogged pipes
- Undersized pipes

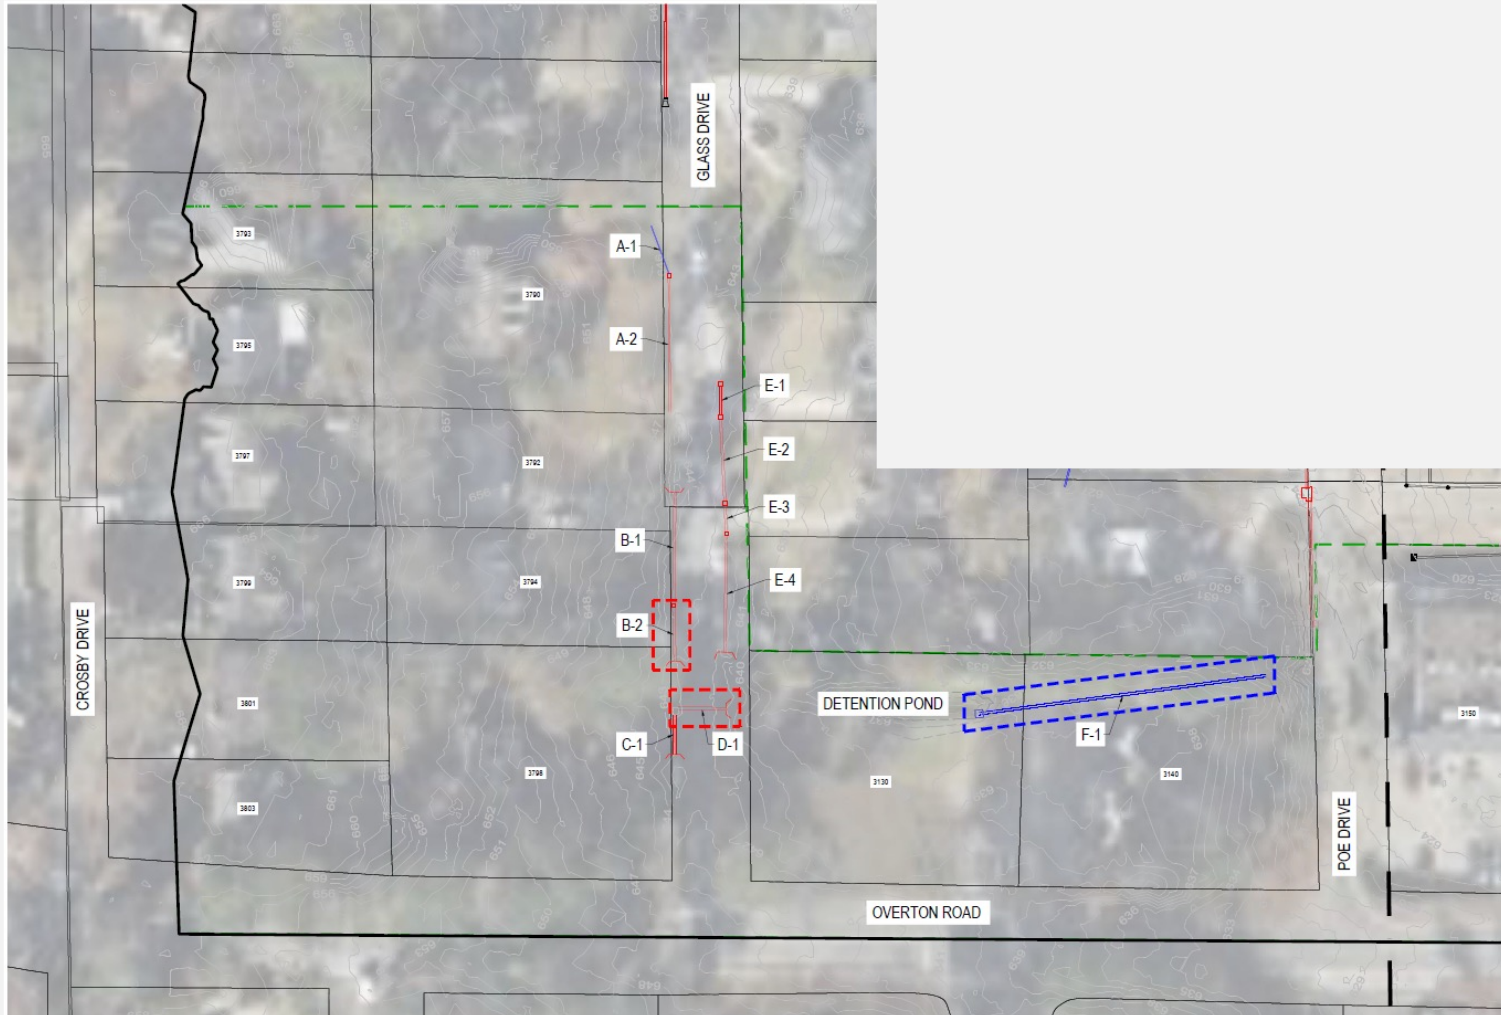
DRAINAGE AREA 1

Concerns within Drainage Area 1:

- Existing grass swales/ditches and appropriately sized pipes within ROW
- Pipe B-2 along the west side of Glass Drive
- Pipe D-1 that travels west to east underneath Glass Drive
- Detention pond located at 3130 Overton Road in Mountain Brook

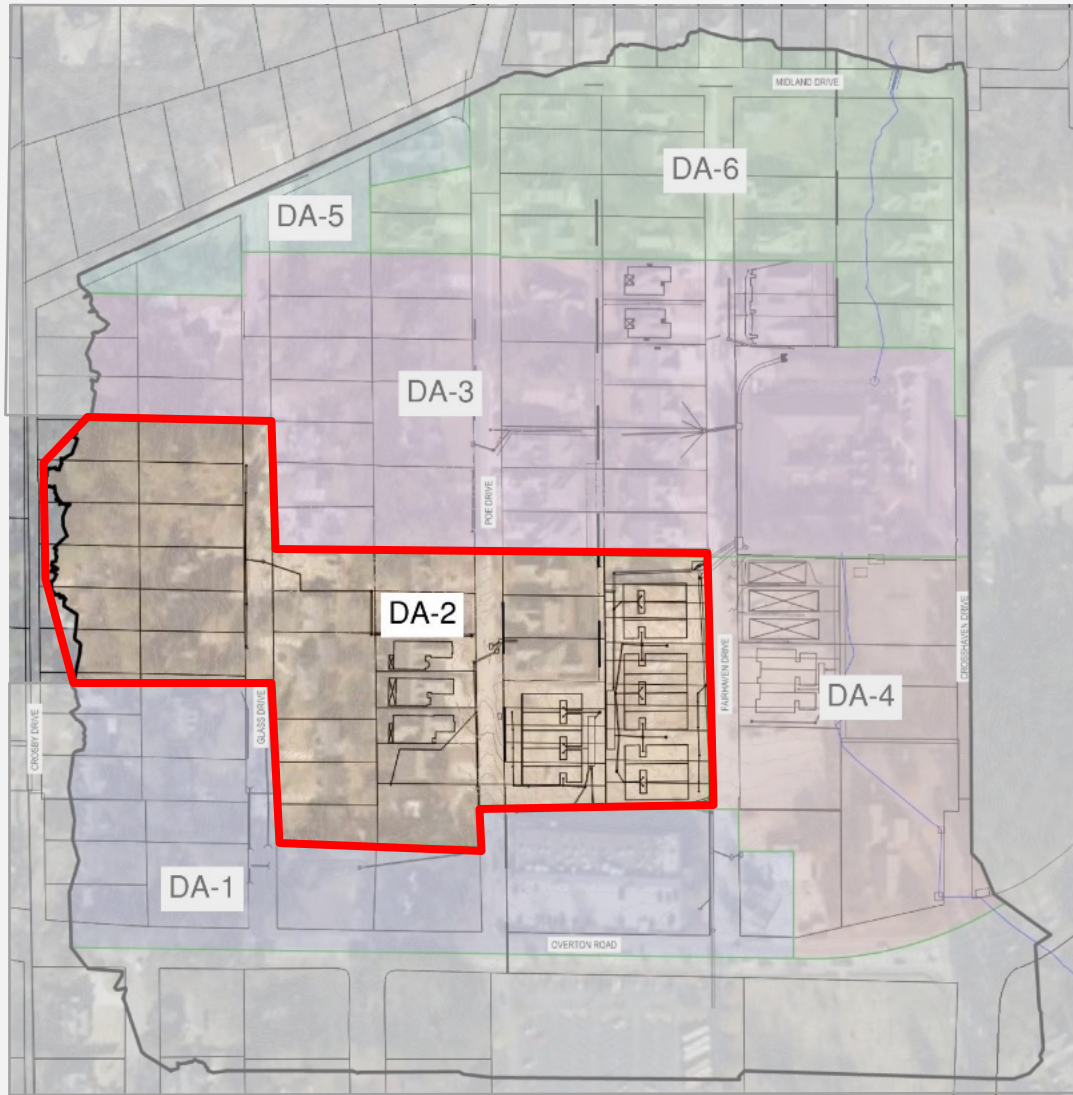
DRAINAGE AREA 2

Summary of Concerns:

- Overgrown grass swales and ditches
- Clogged pipes
- Undersized pipes
- Unknown outfall location of pipes

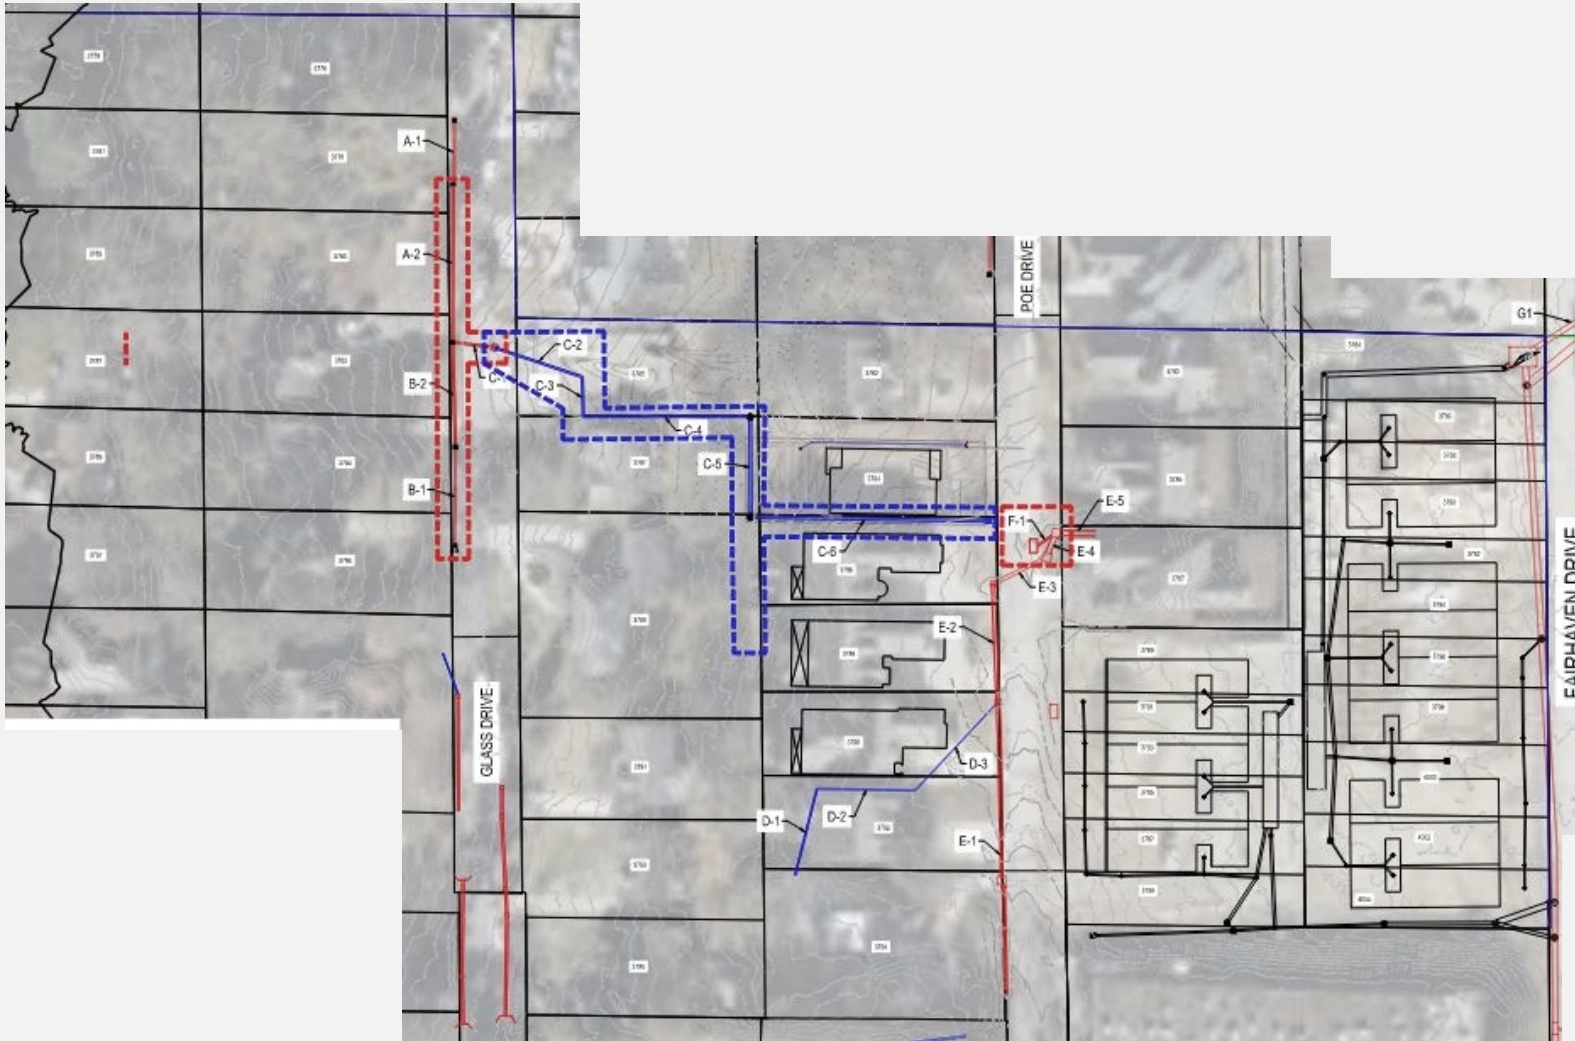
DRAINAGE AREA 2

Concerns within Drainage Area 2:

- Existing pipes within ROW not being appropriately sized
- Unknown pipe sizing of infrastructure running from 3785 Glass Drive to 3786 Poe Drive
- Unknown outlet pipe of inlet 7C
- Pipe F-1 not appropriately sized
- Unknown outfall location of pipe E-5 that runs between 3785 Poe Drive and 3787 Poe Drive

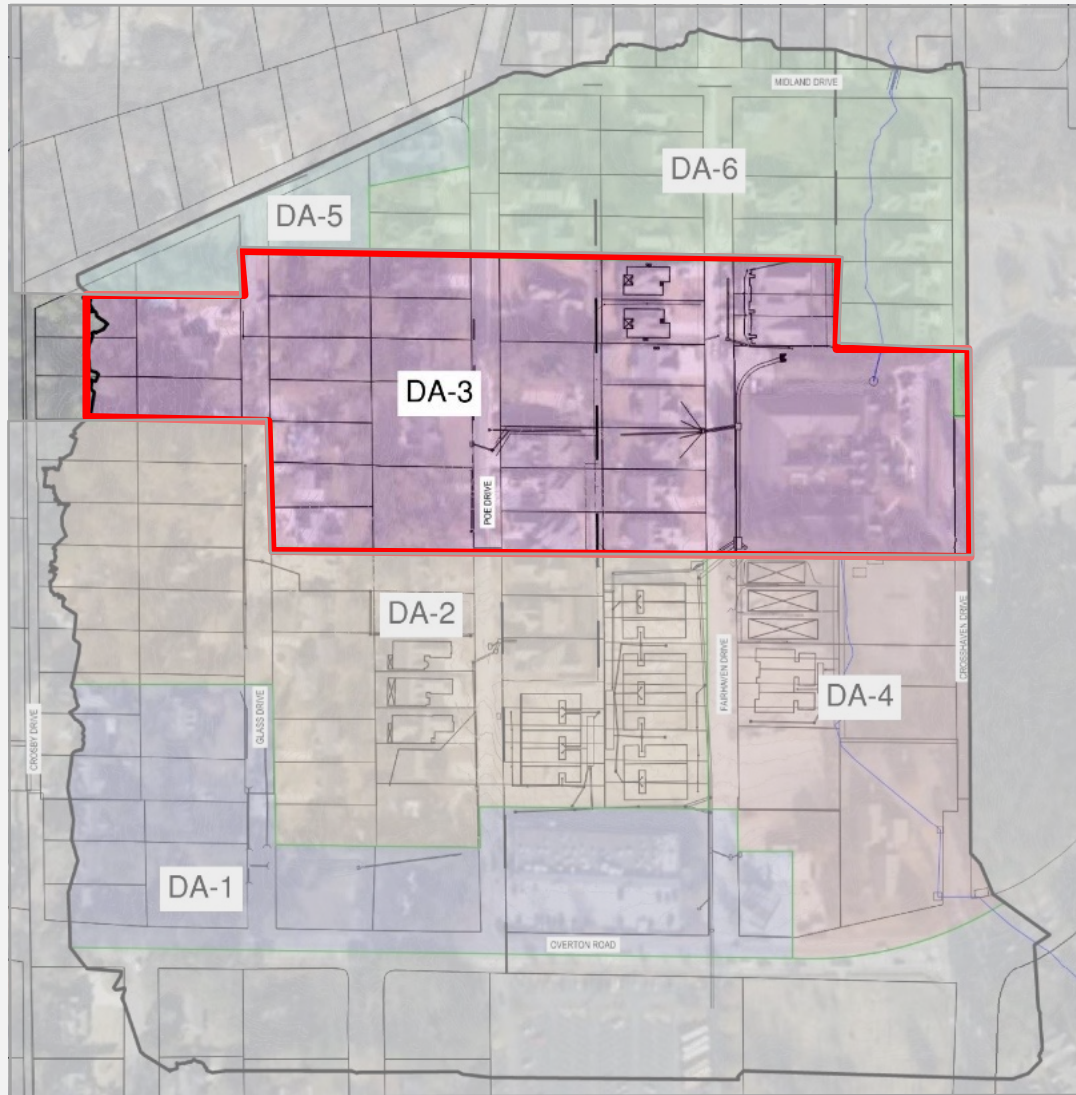
DRAINAGE AREA 3

Summary of Concerns:

- Clogged pipes
- Undersized pipes
- Junction of multiple pipes on Fairhaven

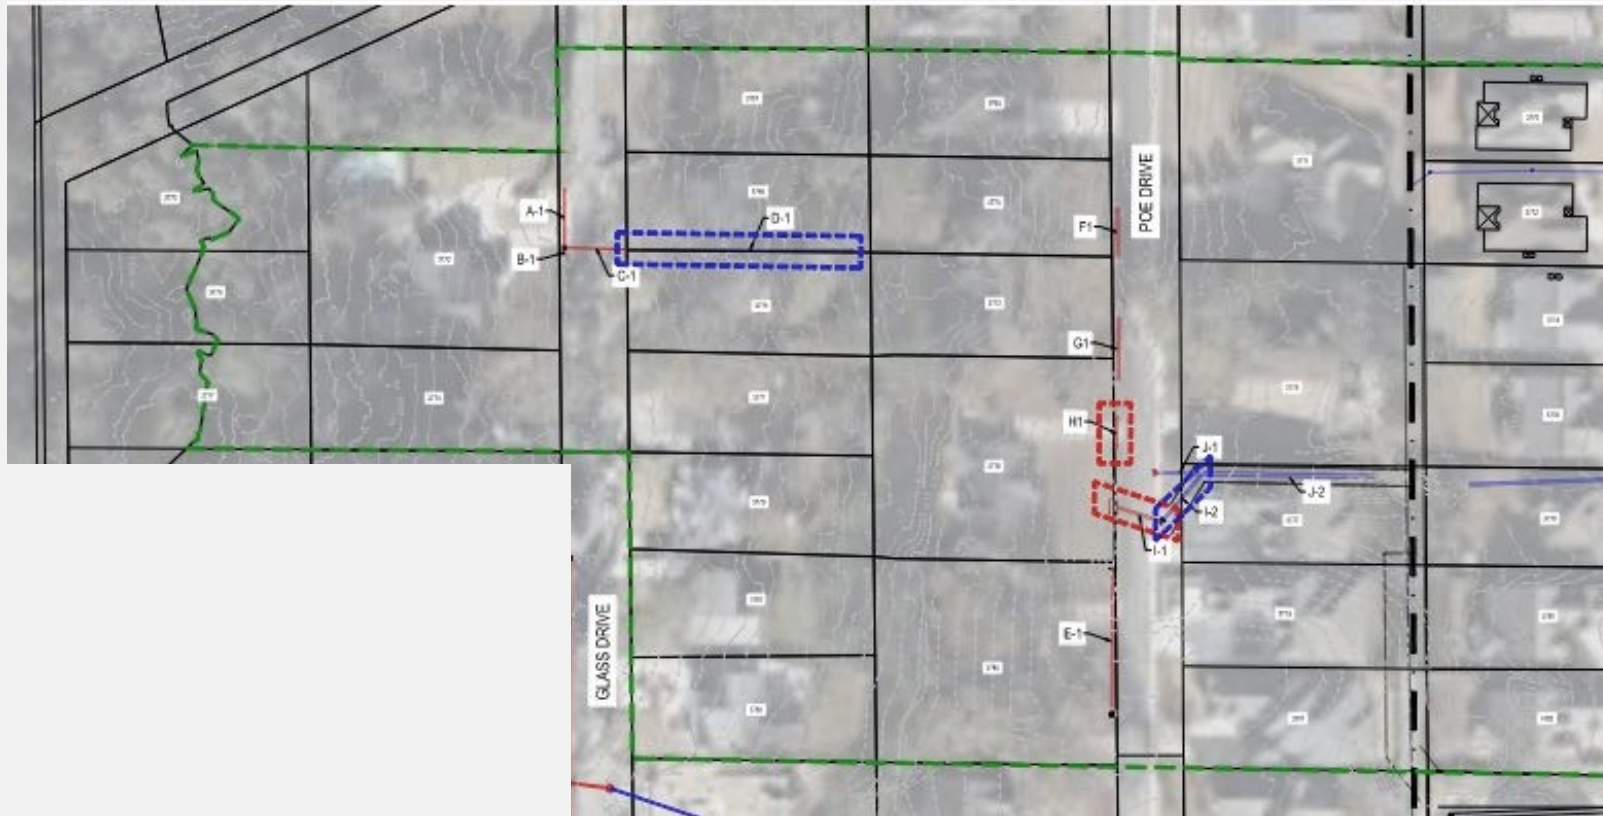
DRAINAGE AREA 3A

Concerns within Drainage Area 3A:

- Existing grass swales/ditches and appropriately sized pipes within ROW
- Pipe D-1 that travels west to east underneath Glass Drive
- Pipe H-1 underneath the driveway of 3776 Poe Drive
- Pipes I-1 and I-2 underneath Poe Drive and into 3777 Poe Drive

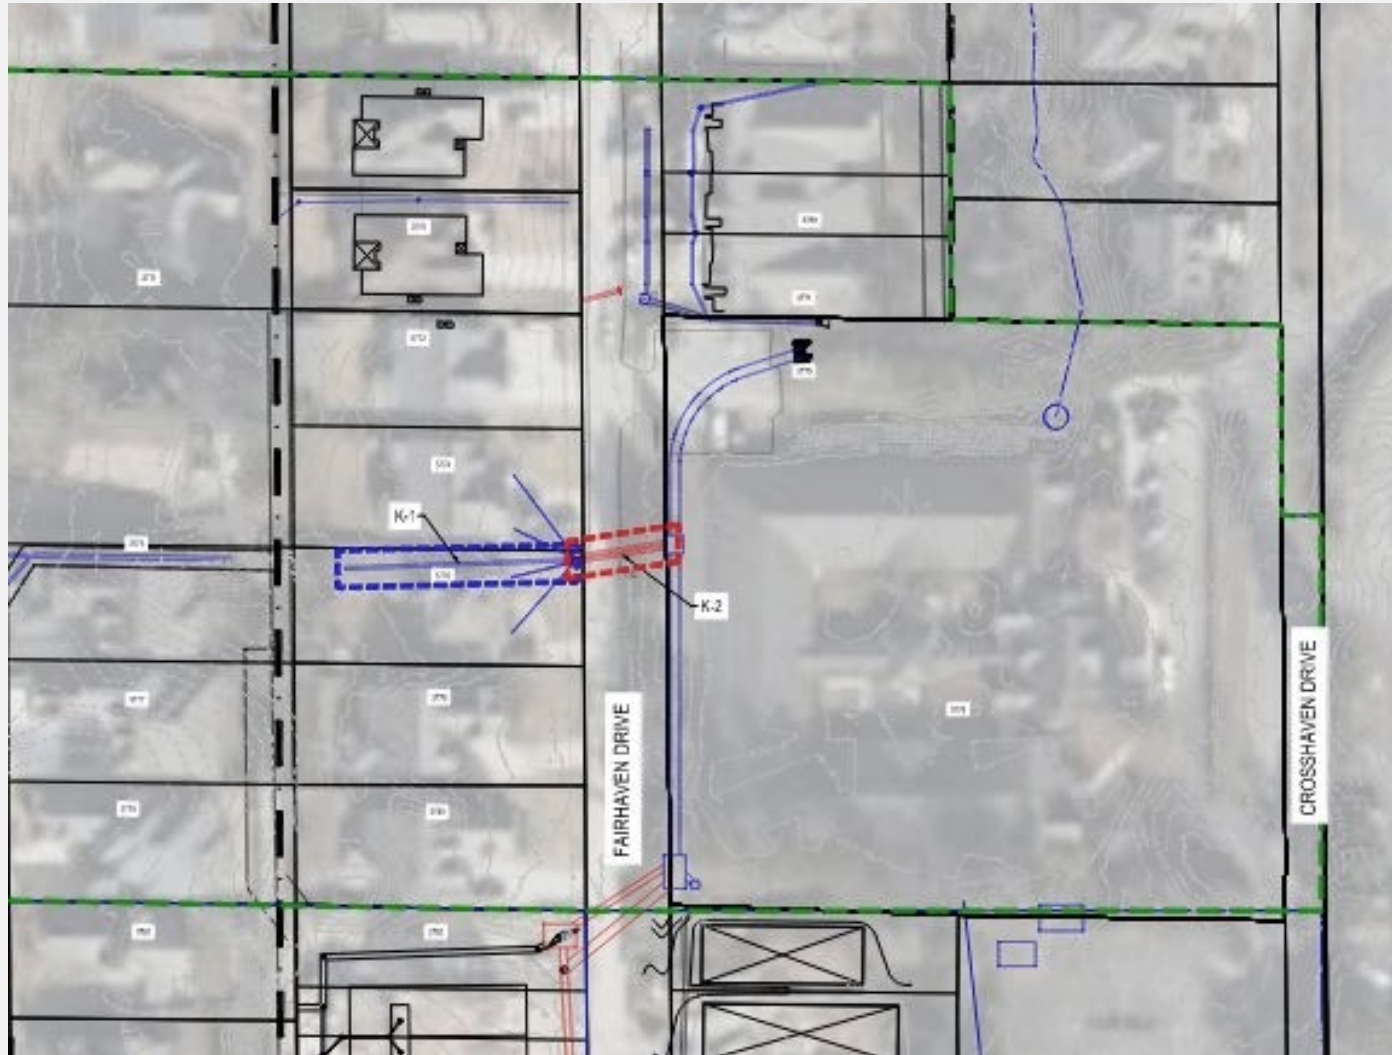
DRAINAGE AREA 3B

Concerns within Drainage Area 3A:

- Two pipes discharging from the junction at 3776 Fairhaven Drive and 3778 Fairhaven Drive
- The junction at 3776 Fairhaven Drive and 3778 Fairhaven Drive
- Pipe K-1 that begins in the rear yard of 3776 Fairhaven Drive
